Survey of the Byzantine Settlement at Çanlı Kilise in Cappadocia: Results of the 1995 and 1996 Seasons

ROBERT OUSTERHOUT

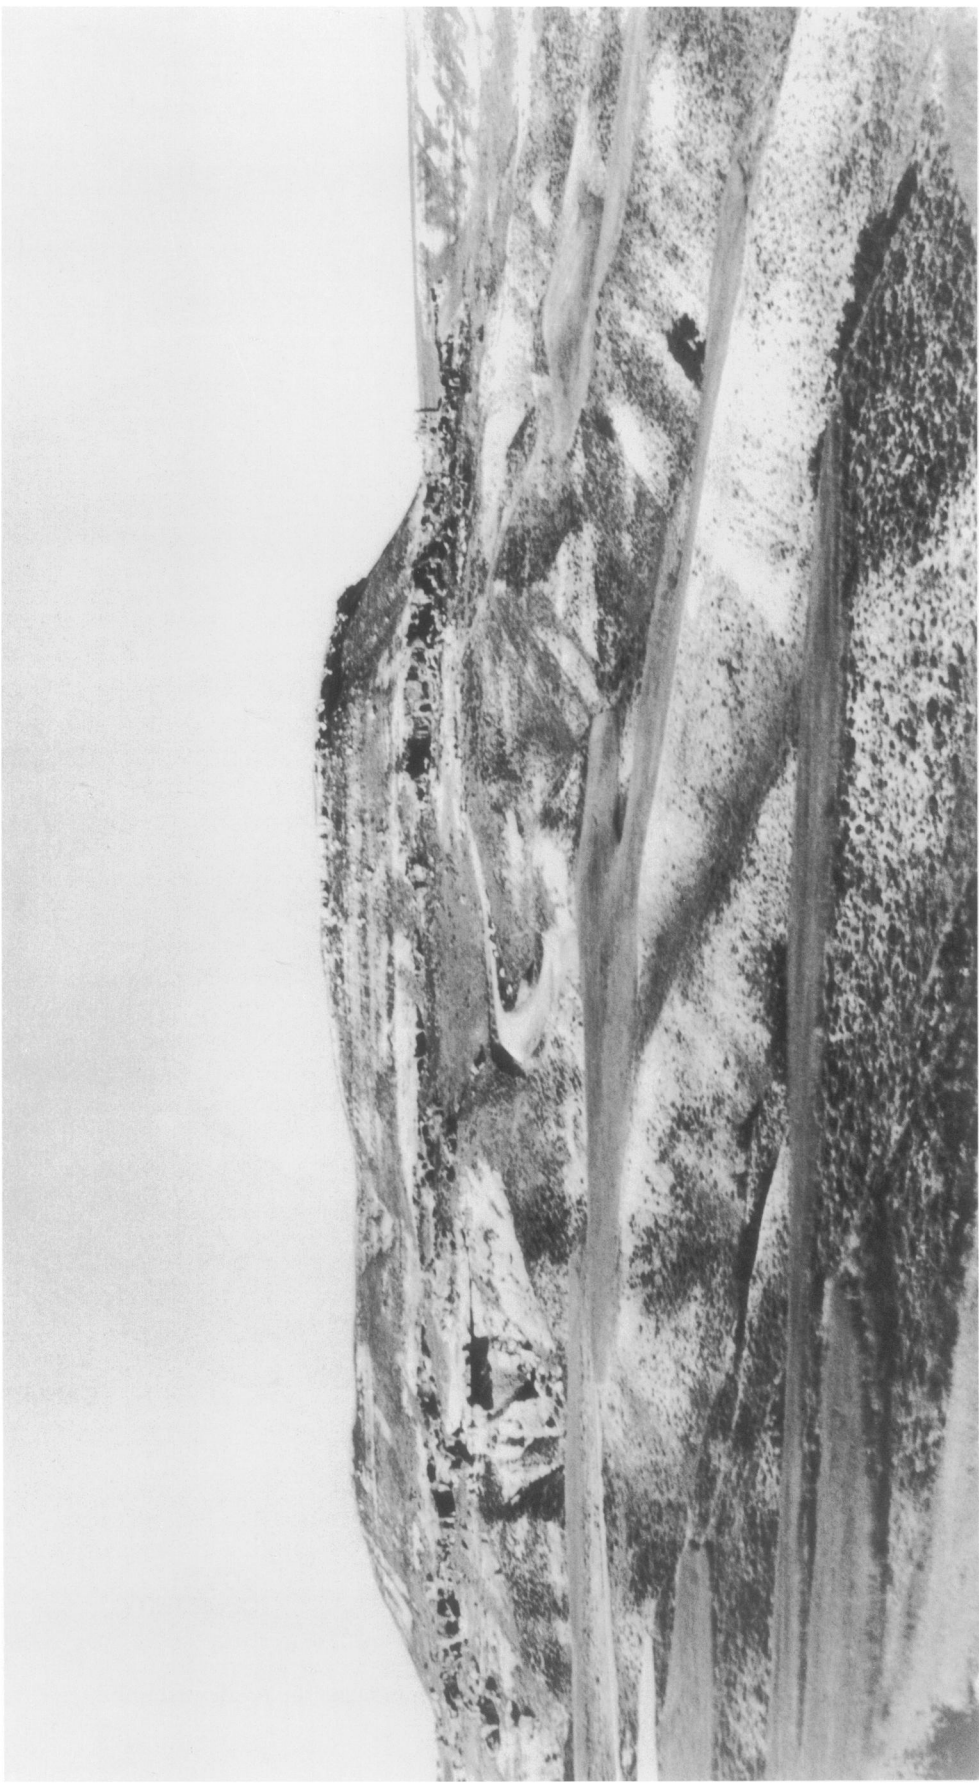
1 Çanlı Kilise settlement, seen from the west. The church is visible on the right, just below the plateau. The line of rock-cut features extends to the left from the church to beyond the edge of the photograph.

A line of rock-carved units extends for about one kilometer, in a reverse S-curve, following a line of exposed volcanic tuff along the slope of the hill to the east and to the northwest of the church (Fig. 1). Using a Total Station EDM (electronic distance measurer), on special loan from the British Institute of Archaeology in Ankara, we took coordinates for the preparation of a contour plan of the site, which is reproduced here (Fig. 2). The use of the EDM allowed us to work rapidly while ensuring a degree of accuracy in our results. All of the architectural features were measured and recorded by hand and then provided with coordinates to relate them to the contour plan. The final site plan combines the results of our high-tech and low-tech recordings (Fig. 3).

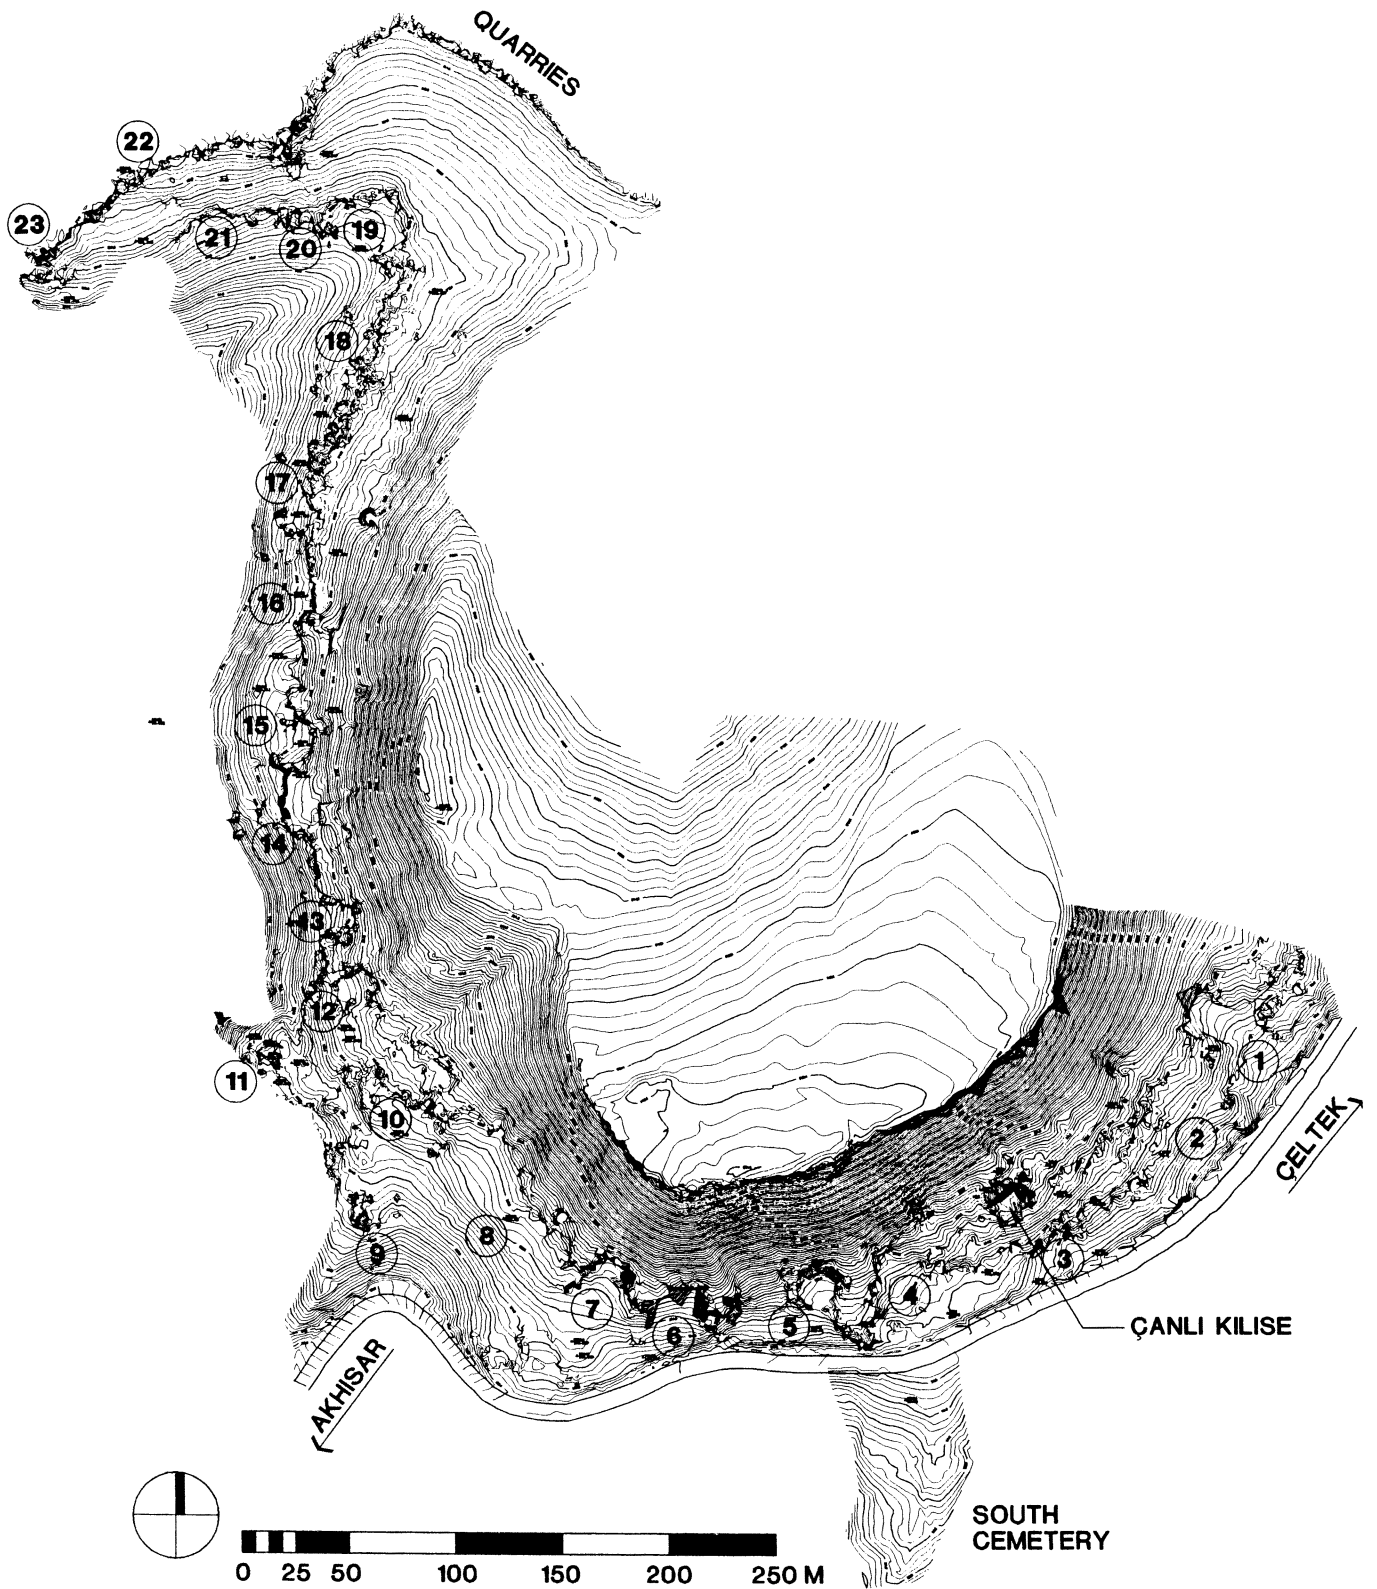
2 Çanlı Kilise settlement, contour plan of the entire site. Circled numbers indicate the residential units.

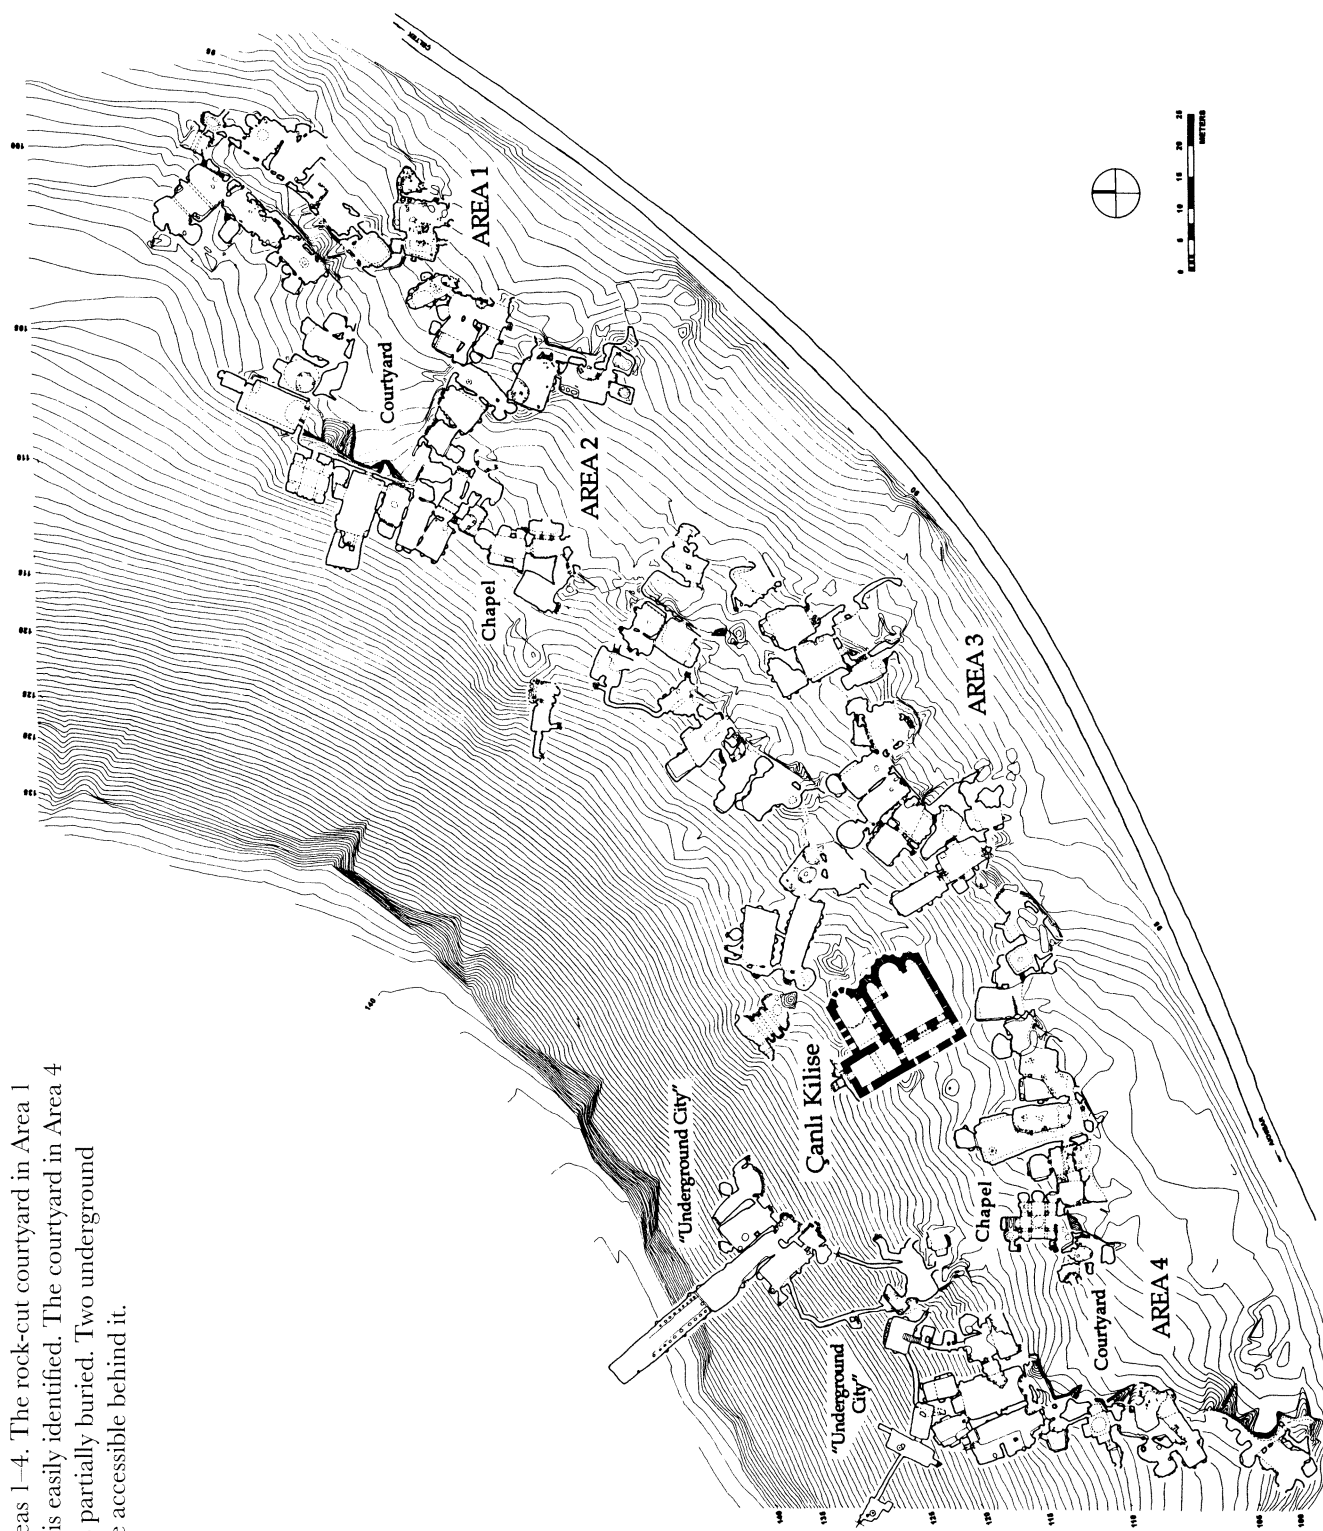
3 Plan of Areas 1–4. The rock-cut courtyard in Area 1 (*upper right*) is easily identified. The courtyard in Area 4 (*lower left*) is partially buried. Two underground features are accessible behind it.

ment (Fig. 3). Following the common parlance of Cappadocian studies, we refer to these as “underground cities,” although “underground villages” is perhaps more appropriate to their small scale. The entrance tunnels were protected by an elaborate series of rolling stone doors. However, the forms of our underground elements were different from the other “underground cities” of the region, and several included rubble walls as well as rock-cut elements, chambers with cornices and barrel vaults, and even some architectural sculpture. One underground room above Area 14 preserved a uniquely carved gable (Fig. 16). On careful examination, we concluded that the larger and more carefully carved of our “underground cities” were actually courtyard houses that had been buried by landslides and subsequently converted into refuges with the addition of tunnels and rolling stone doors. This may suggest something of the ongoing life at the site, and it parallels the transformations at other courtyard residences, where additional back rooms guarded by rolling stones were carved.

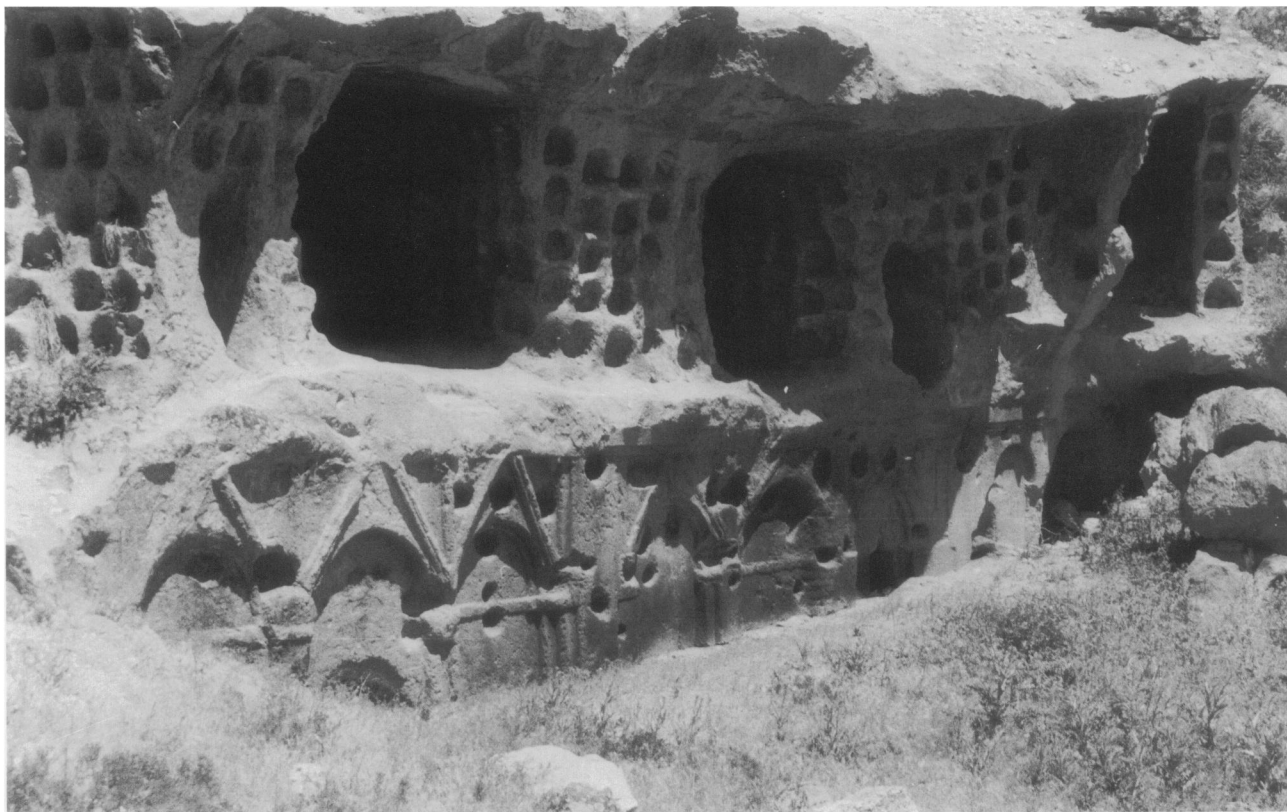
4 Area 1, facade of courtyard unit, looking north. The open portico has fallen, and the arcading is on what was originally the interior facade of the portico. The pigeonholed spaces above were probably screened by the original facade.

In three seasons at Çanlı Kilise, we have recorded about twenty-five large, rock-cut living units, as well as dozens of smaller, simpler ones. Most commonly, the large units consist of a series of rooms organized around three sides of a courtyard cut into the slope of the hill (Figs. 4–6). There is often evidence of a rock-cut portico along the main facade. In Area 13, for example, two arches of the open arcade remain, but most of the other courtyards preserve only remains of the decorated interior facade of the portico, as in Area 1. Many of the rooms have distinctive plans, and most units preserve both a chapel and a large, centrally positioned hall. The halls are often lavishly articulated and may be set either longitudinally or transversally, terminating in a rectangular niche. Many units preserve smaller cruciform or centrally planned halls as well. Some units have kitchens, topped by conical vaults, as well as rooms that may be identified as storerooms, cisterns, stables, and dovecotes.

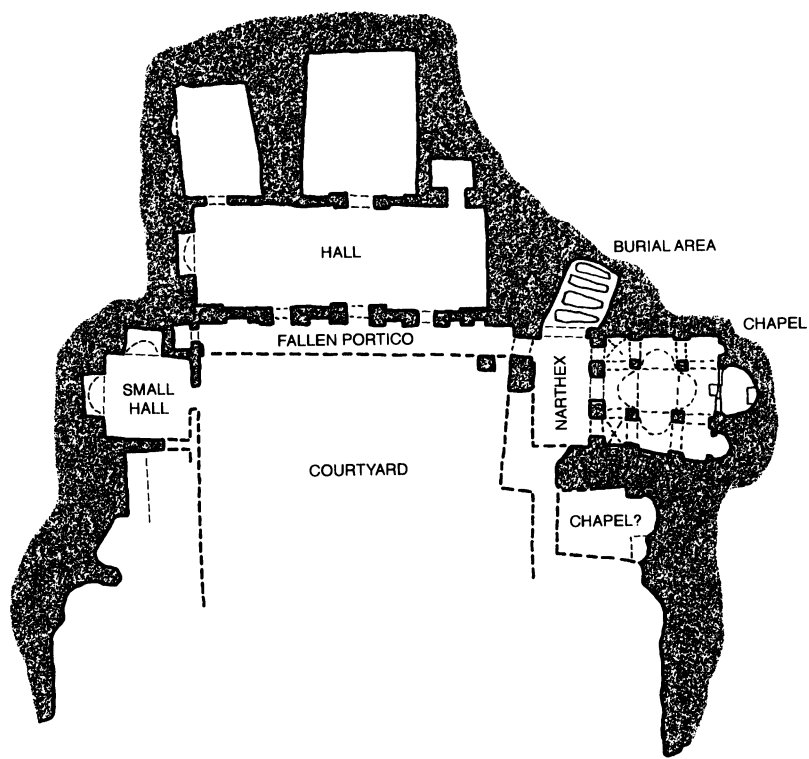
5 Area 7, reconstructed plan of courtyard unit. The major living spaces are organized on the main facade, with the chapel set off to one side.

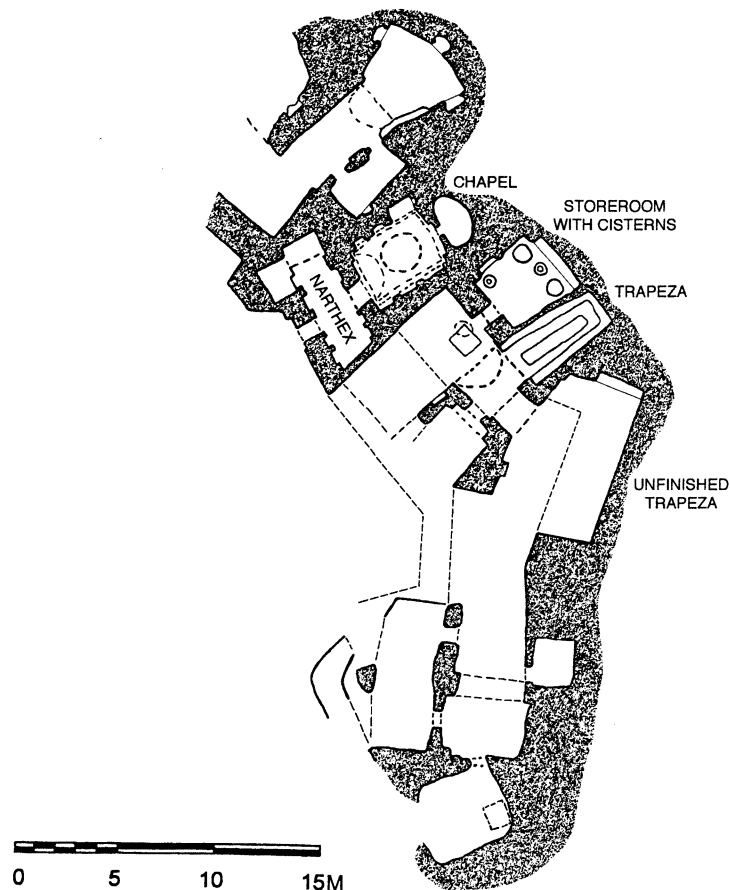
7 Area 17, reconstructed plan of monastery, with chapel and *trapeza* in central position

identified as a monastery. Its plan was considerably less well organized than those of the courtyard units, but it included a barrel-vaulted chapel and a dining hall, or *trapeza*, side by side—the latter identified by its rock-cut table and benches (Figs. 7, 8). Such distinctive features were found only in this one example.

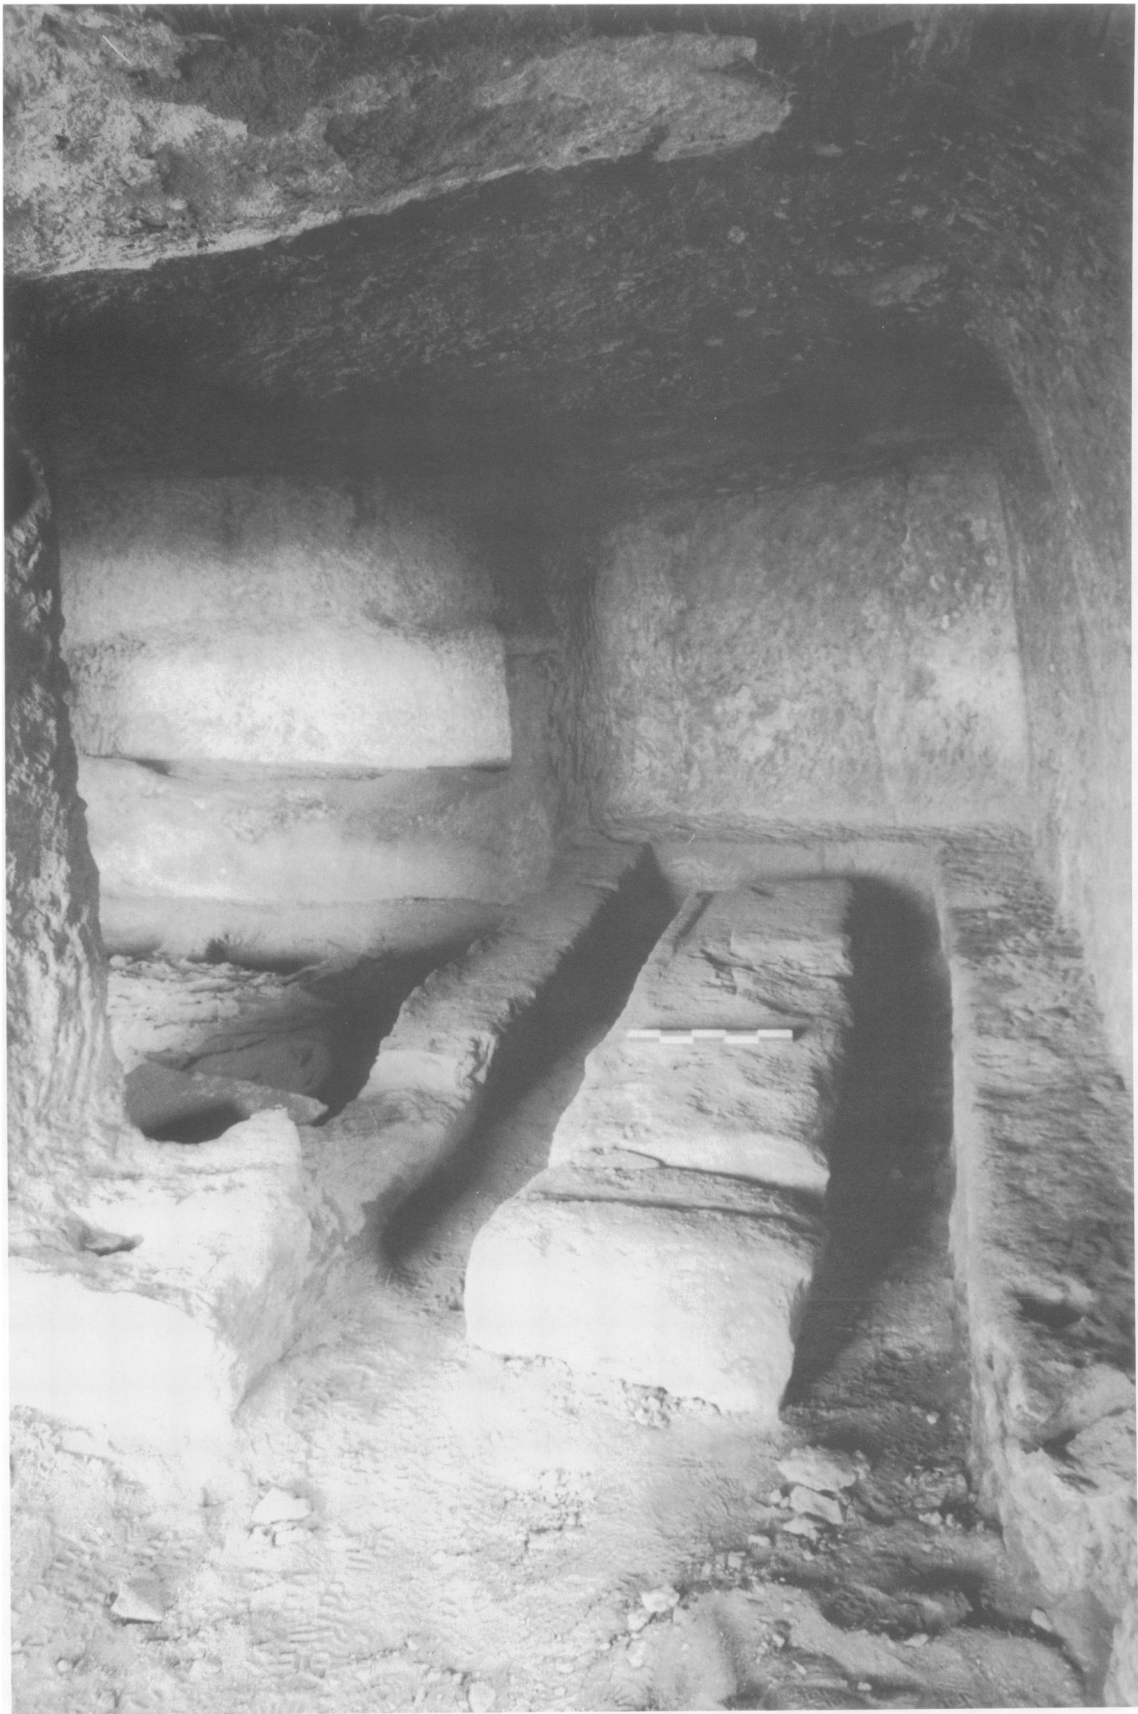
8 Area 17, interior of *trapeza*, looking east. Originally a wall separated the *trapeza* from the storeroom (to the left).

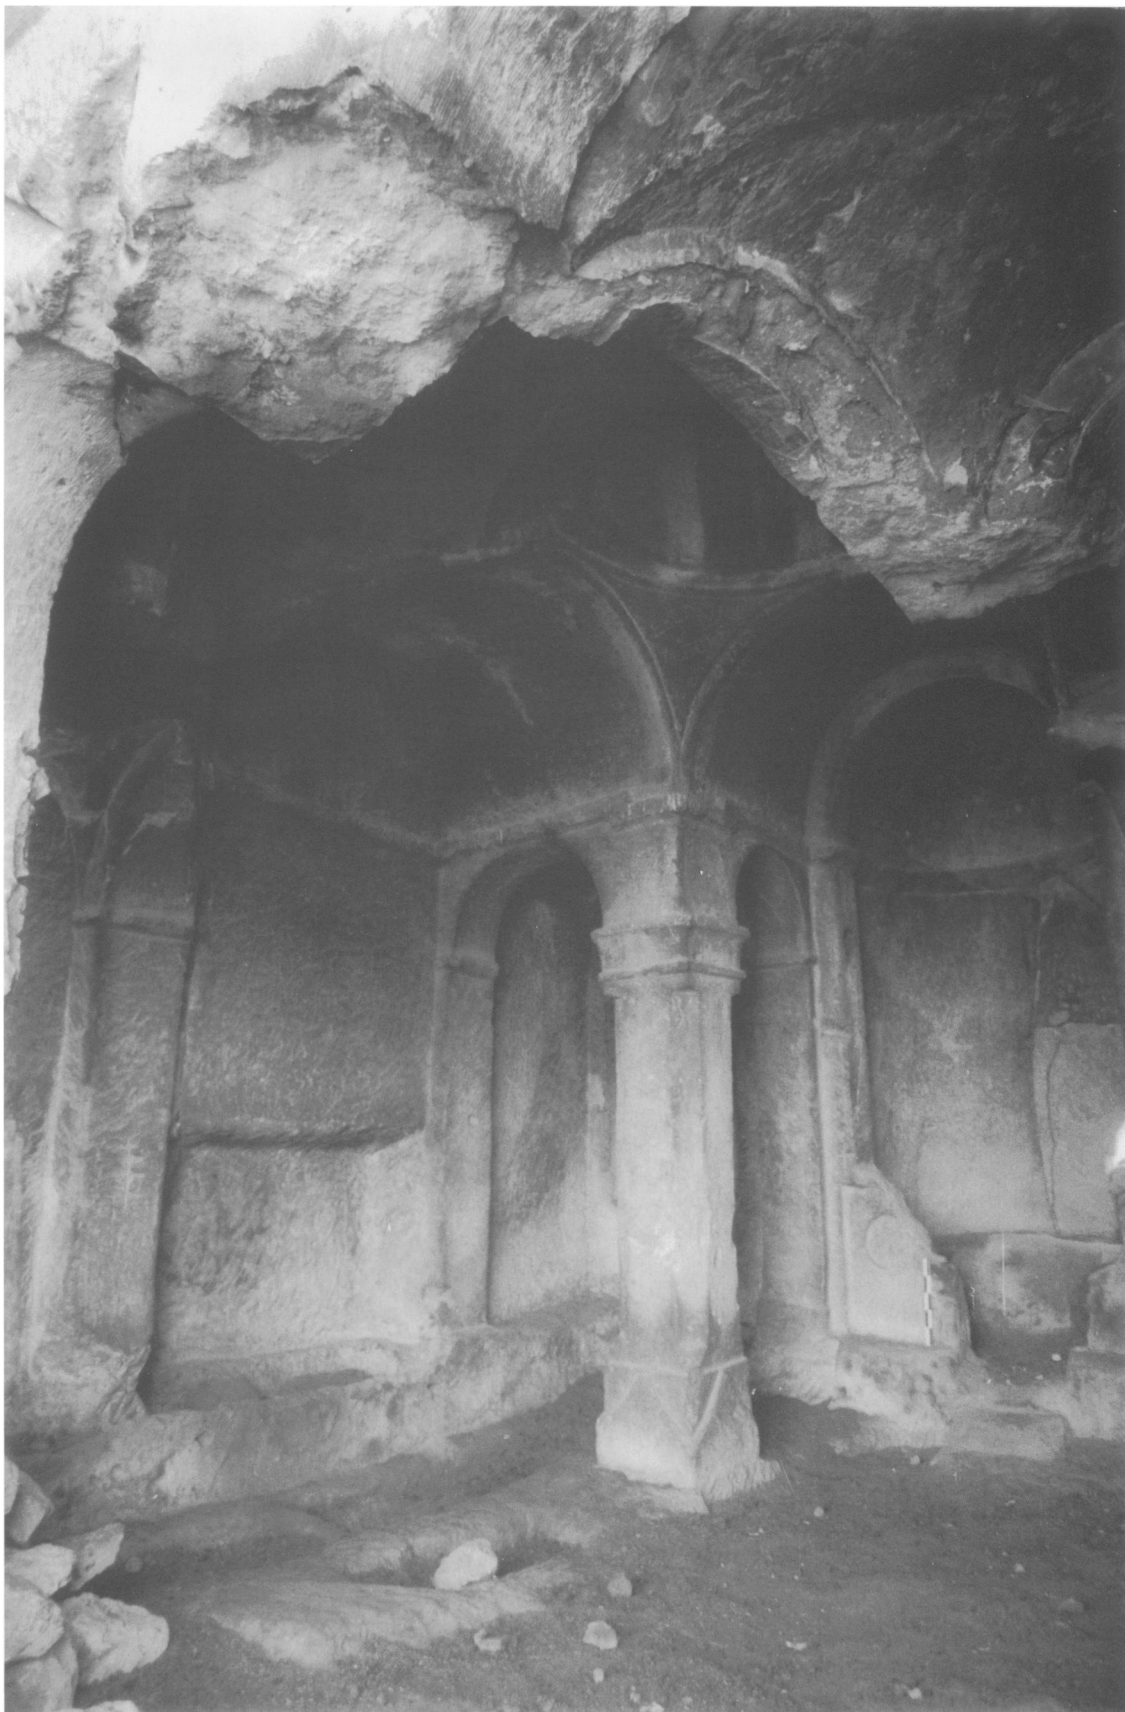
9 Area 6, interior of chapel, looking northeast. The sanctuary is raised two steps above the naos, separated from it by a low barrier. Cuttings appear in the reveals above for a wooden architrave.

In addition to the architecture of the churches and chapels, we have recorded evidence for fresco decoration and for the details of the sanctuary. There does not appear to have been a standard form of templon separating the sanctuary from the naos; most chapels included a low barrier, but only one (in Area 2) preserves any evidence of a carved epistyle. However, there is evidence of alterations in several bemas, and most (but not all) examples preserve cuttings for the inclusion of a wooden epistyle.¹¹

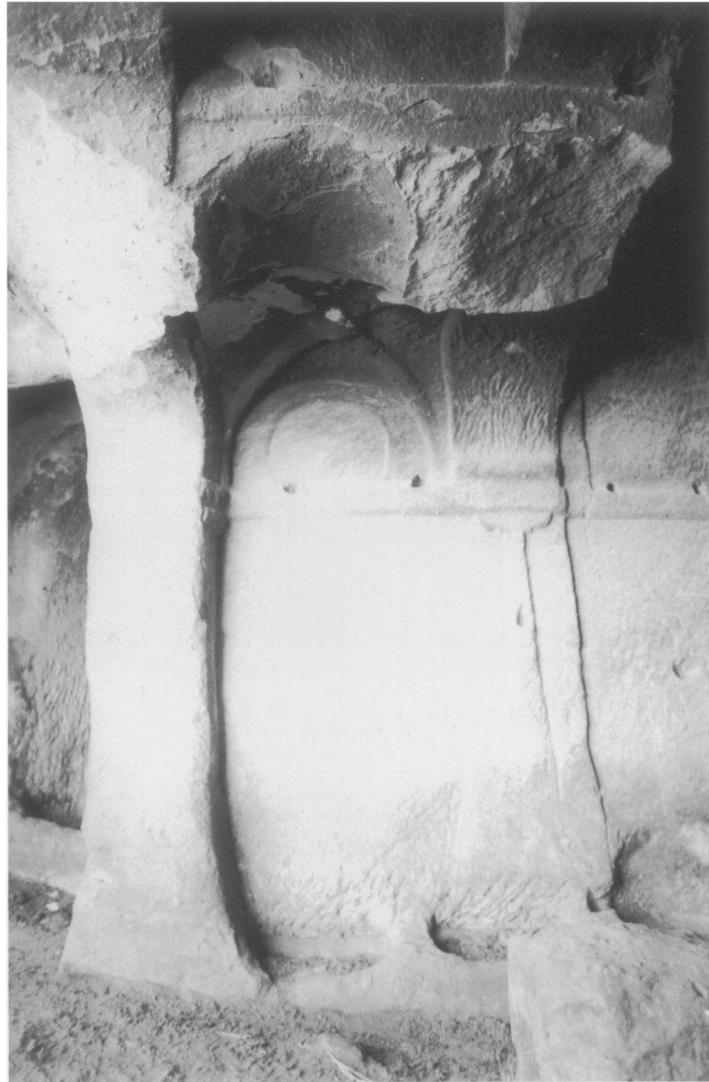
10 Area 7, interior of chapel, detail, looking north. The pilaster is decorated with a "proto-Doric" colonnette, and the corner bay is covered by a ribbed groin vault.

which a tenth-century date is sometimes suggested (Fig. 10).¹⁰

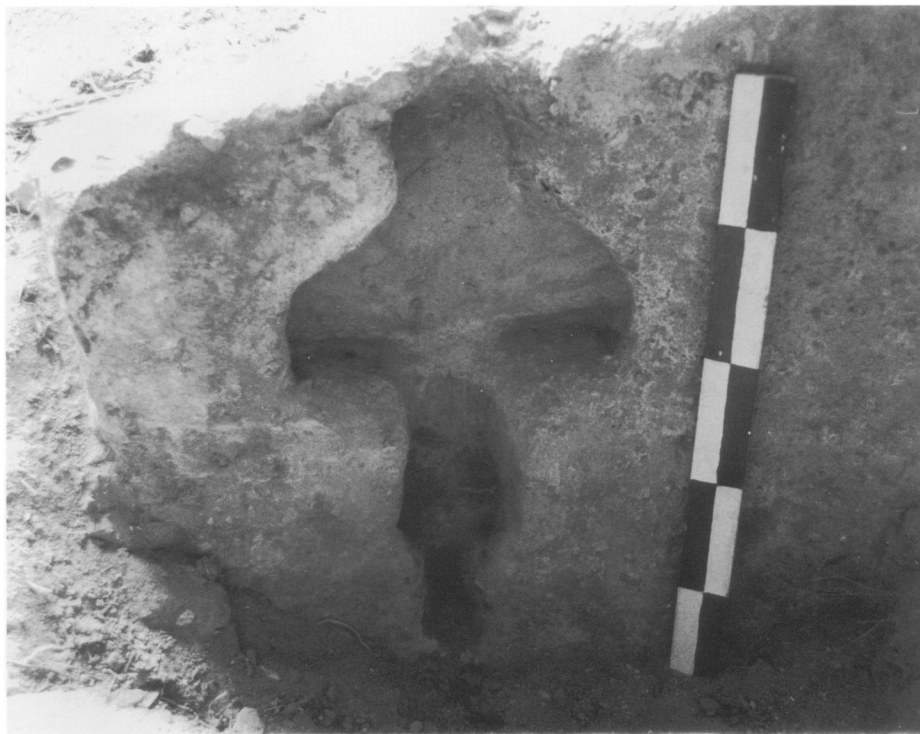
13 Area 12, rock-cut chapel, cruciform cutting on inner surface of sanctuary barrier

On the inner face of the templon of this church we discovered a cruciform cutting, about 40 cm across, perhaps once housing a reliquary or a processional cross (Fig. 13). It includes both flared arms for the cross and an extension for the handle.

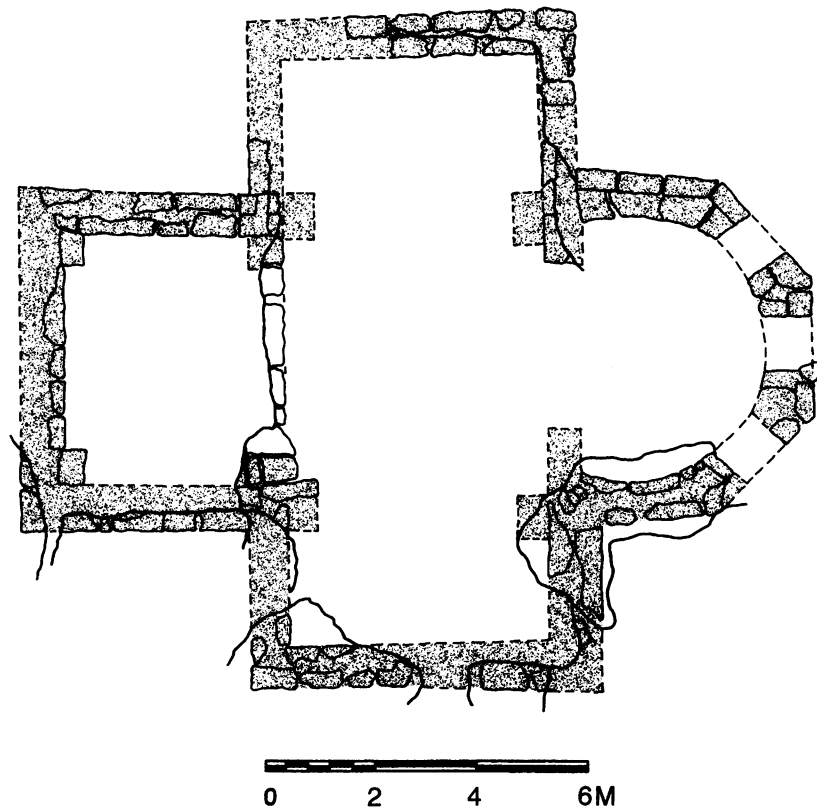
17 North Settlement, plan of church

We also cleaned and recorded the masonry foundations of a cruciform church and an adjacent rectangular building about a kilometer north of the site, which we called the North Settlement. The church had a horseshoe-shaped apse with large windows (Fig. 17). The buildings in this area date from the early Christian period, perhaps sixth century, and the church compares in plan and details to other examples of early Christian masonry architecture in western Cappadocia.¹⁴ The North Settlement does *not* appear to have been occupied at the same time as the main settlement. No glazed ceramics were found in this area, and some late Roman red-slip ware was noted. Nor is there evidence of a rock-cut settlement around the buildings. Significantly, fragments of mosaic decoration were found in the collapsed vaulting of the church, and these may be the first evidence of mural mosaic decoration in Cappadocia (Fig. 18). To the east of the church, along the ridge of hard volcanic tuff, was much evidence of the quarrying for the building stone. To the northeast were a small cemetery and the entrance to an underground feature, now blocked. This particular site could not be fully examined and would clearly benefit from a proper excavation.

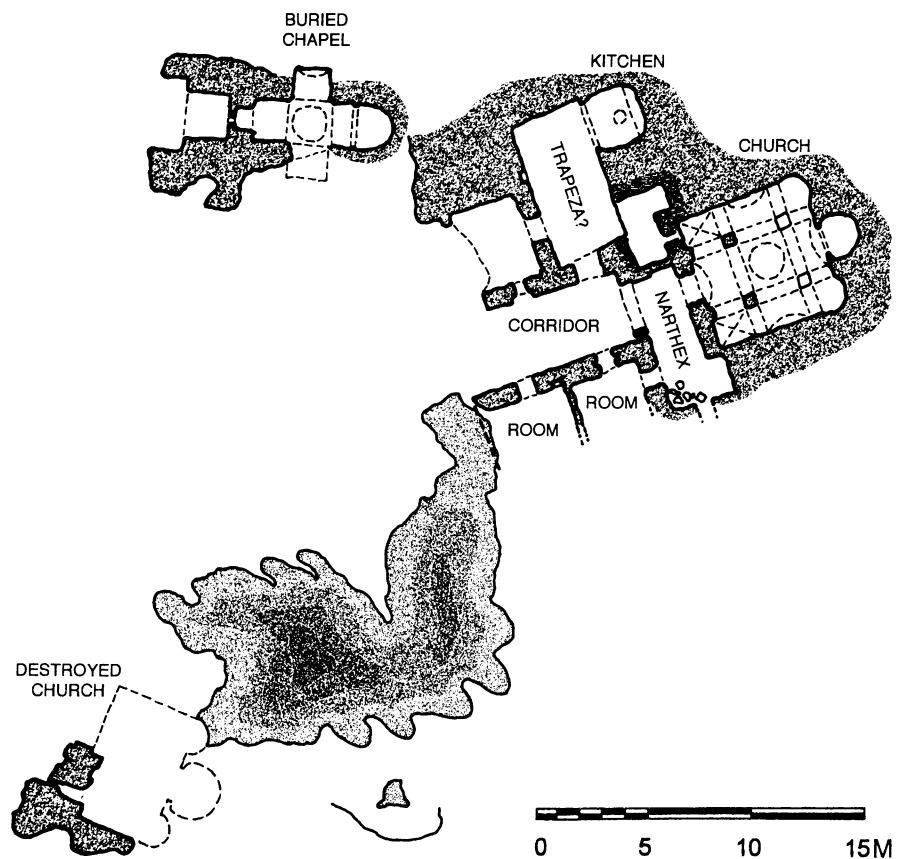
19 East Settlement (monastery?), plan

monastery, composed of a small cluster of rooms with two large churches and two smaller chapels (Fig. 19). The organization of this unit differs significantly from the others, with the central feature being a large church reached by a long corridor that provides access to the other main rooms. An L-shaped space to one side of the church may have included the *trapeza* or dining hall, but its interior is buried by more than a meter of dirt. The crossarm of this room is topped by a conical vault and a chimney that suggest it was the kitchen. Unfortunately, most of the spaces in this area have become eroded or have been buried by landslide.
